Step 3: Current Conditions

Soil Resources

Current Conditions - Erosion Processes

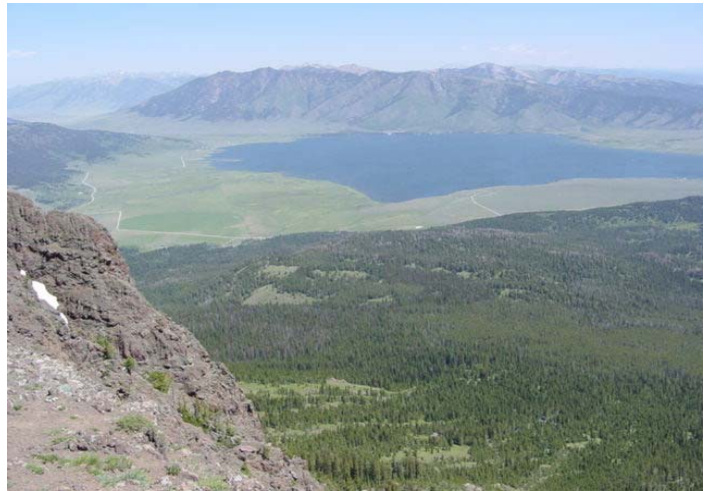
Figure 6 Northwest view of the Blue Creek Watershed-Henrys Lake in Background.

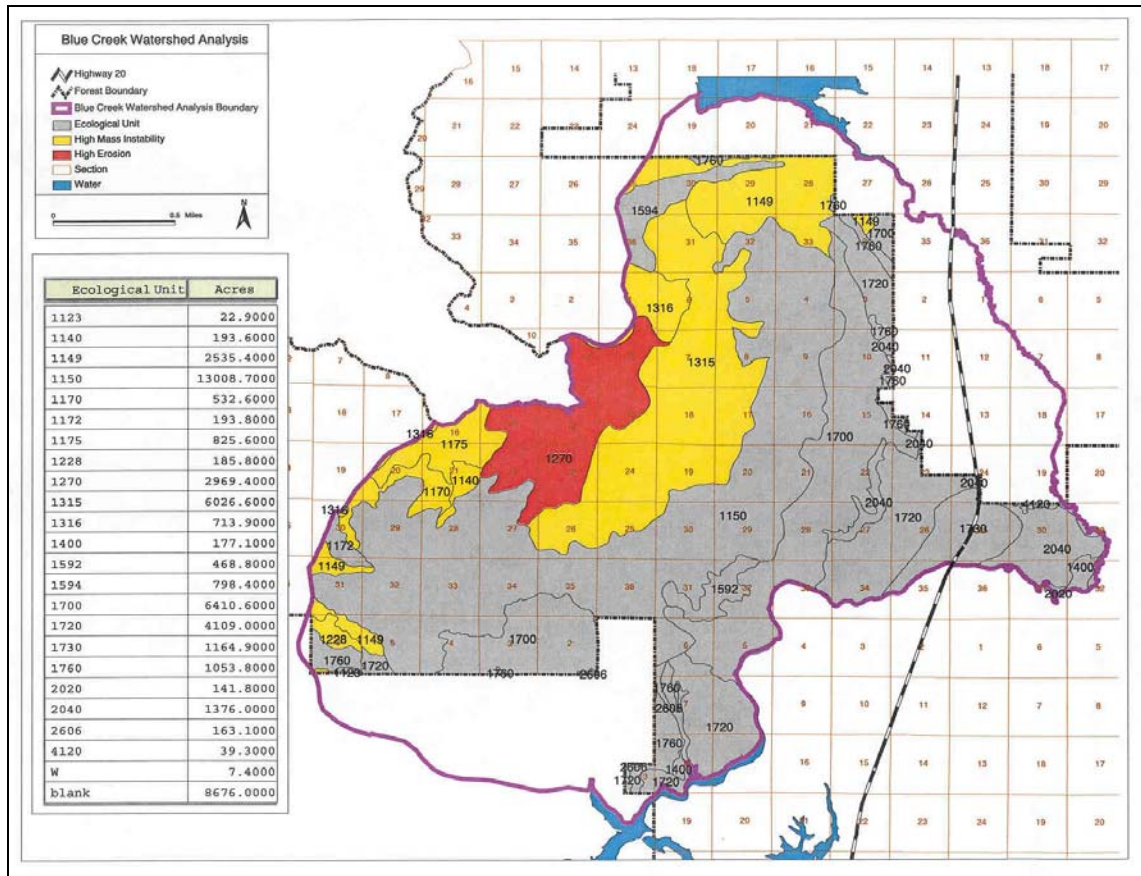
A portion of the watershed (approximately 11,015 acres or 20%) has unstable landforms that are subject to mass instability and landslides. Ecological units that have been identified as being unstable are EU 1140, 1149, 1170, 1175, 1228, 1315, and 1316. Figure 10 shows the ecological units having high mass movement potential colored in yellow and high erosion potential colored in red.

Figure 10 Erosion and Mass Movement Potential in the Blue Creek Watershed.

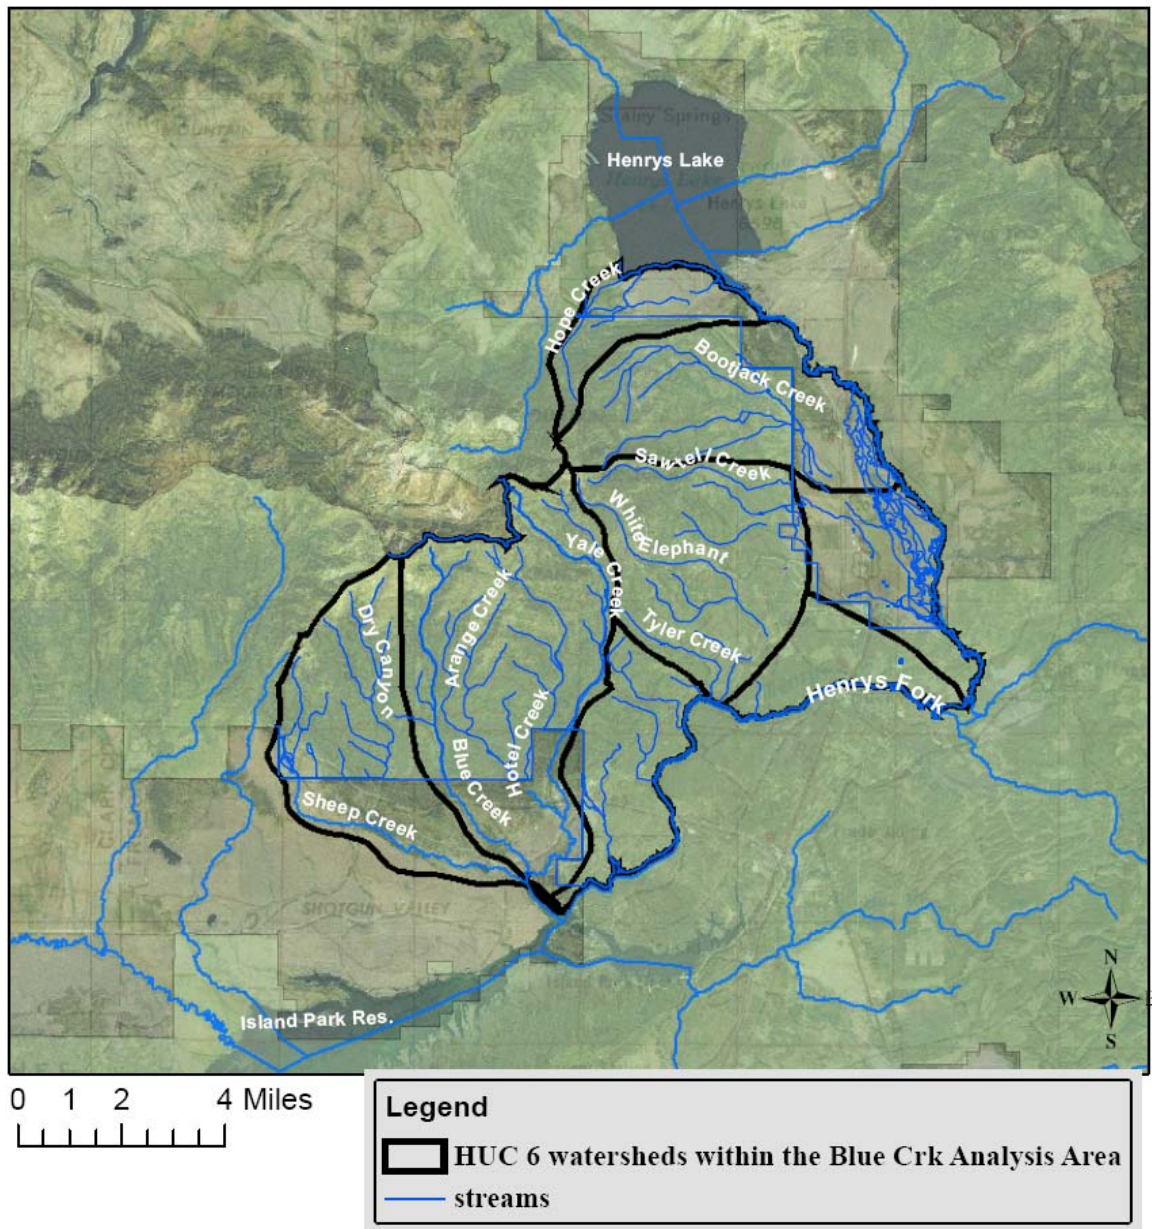
Figure 12 Major streams within the Blue Creek analysis area.

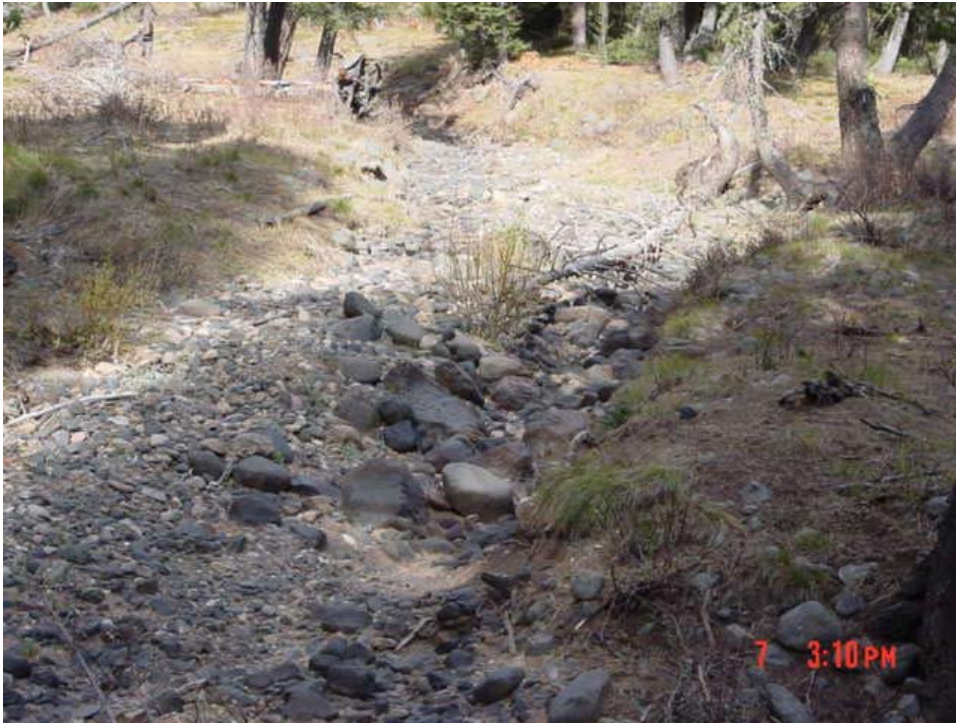
Figure 13 Blue Creek

Much of Blue Creek has downcut several feet. One reach has downcut as much as 10 feet.

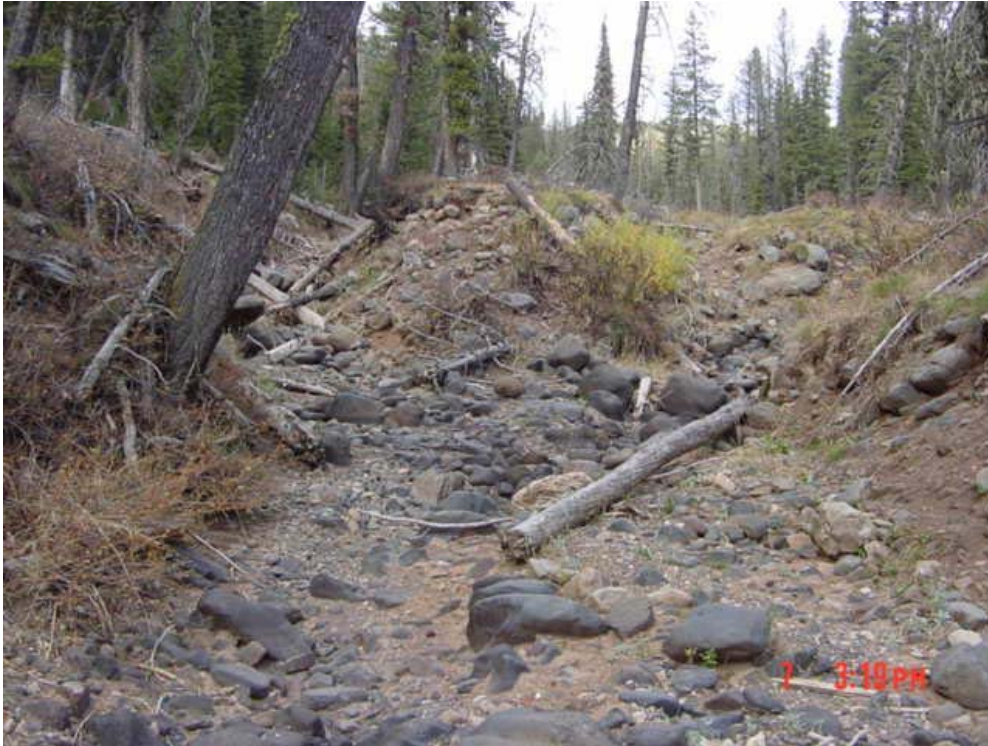
Figure 16 Looking upstream.

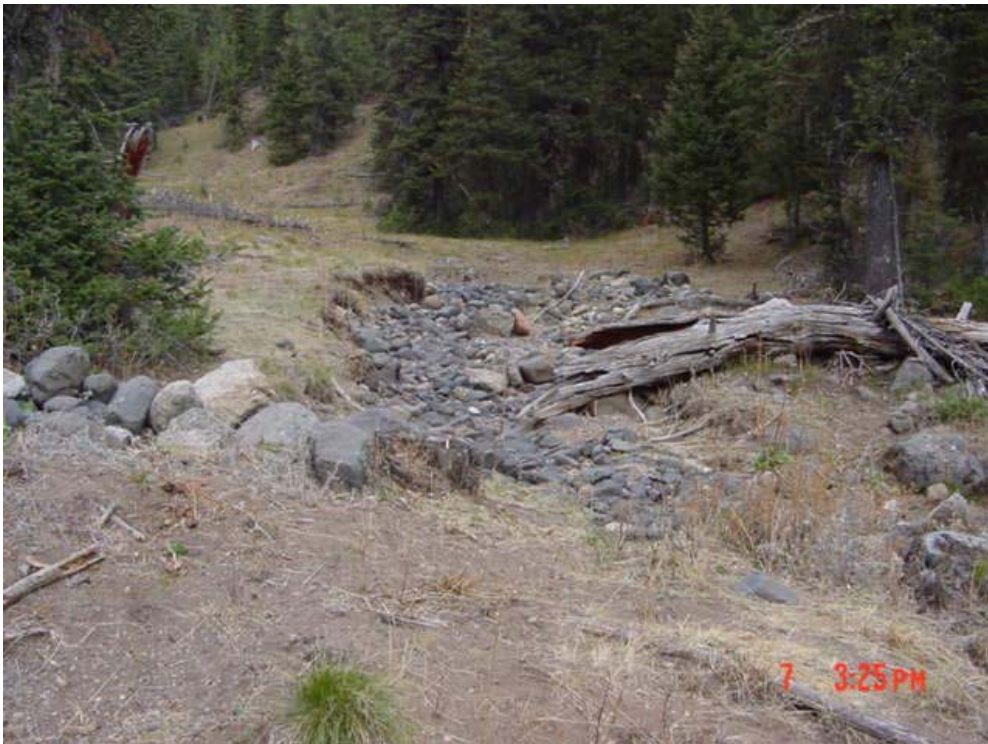
Figure 17 Downstream confluence of the split channel.

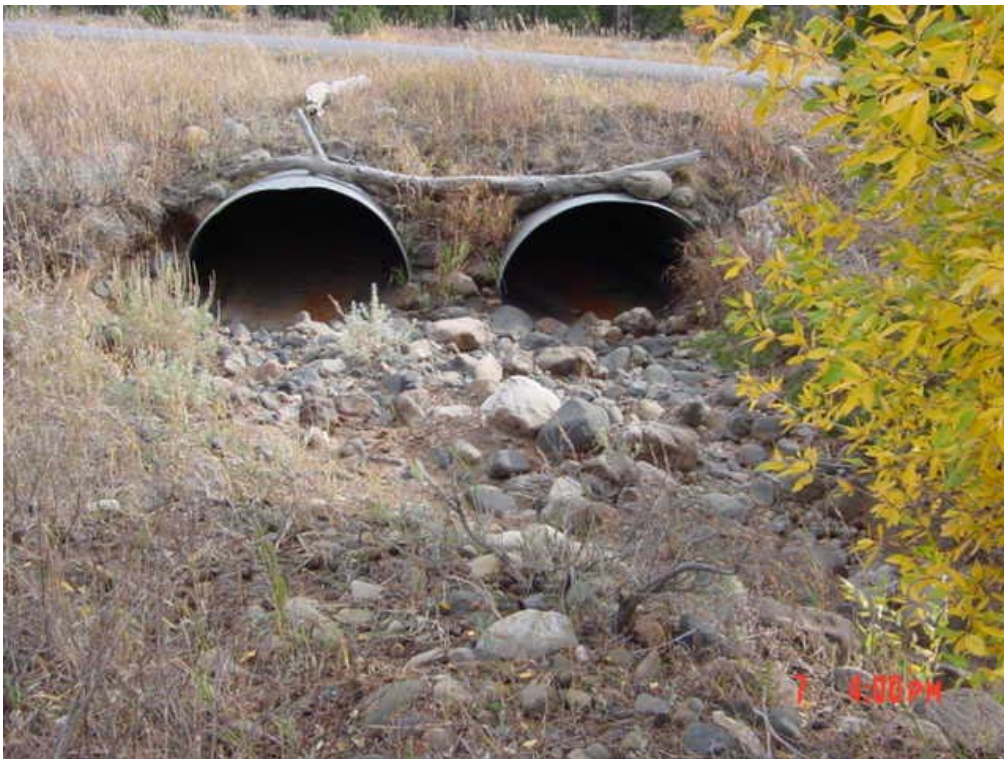
Figure 19 The majority of the flow goes through the left culvert.

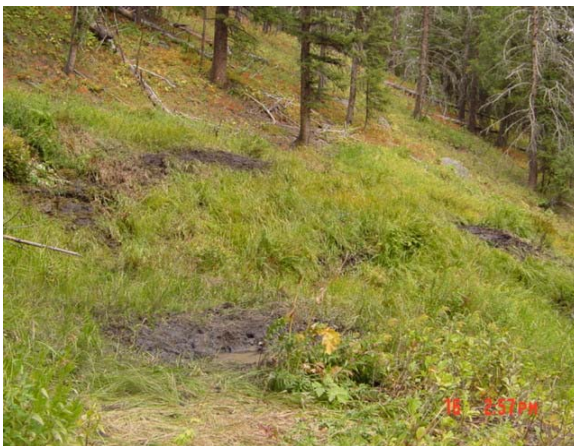
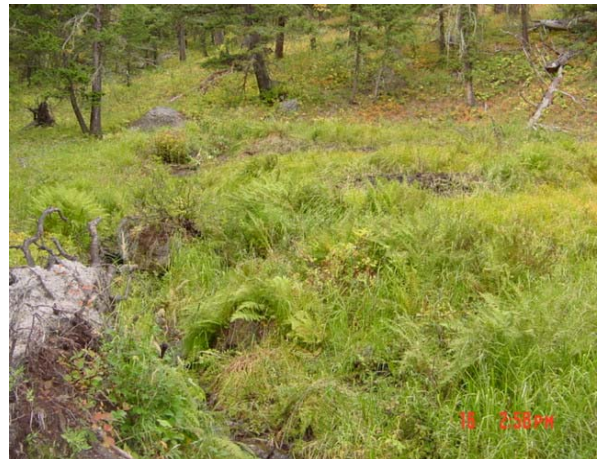
Figure 28 Coffee Pot Creek

Coffee Pot Creek begins at a series of springs about 1 mile above the Stamp Meadows road (FDR 052). Elk are using the site for wallowing. Flow at the spring site is relatively small (only about 25 gallons per minute), but flows increase downstream to about 2 cfs. Above the springs there is no defined channel.

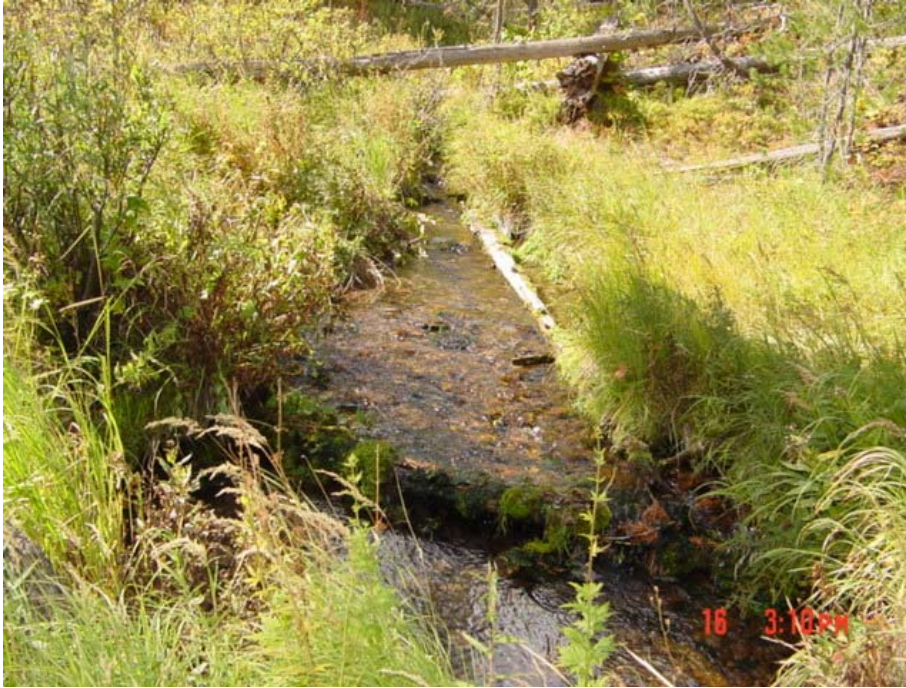
Figure 30 Coffee Pot Creek several hundred meters below the spring site. Flow here is about $\frac{1}{4}$ cfs. Temperature is about 5 deg. C.

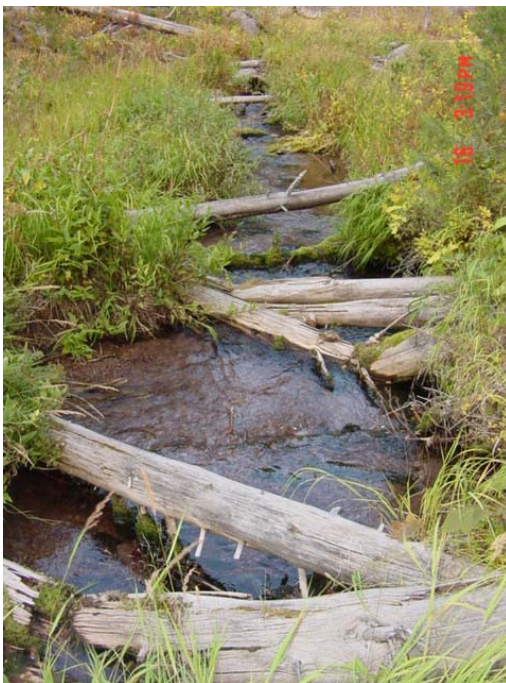
Figure 31 Coffee Pot Creek about $\frac{1}{4}$ mile below the springs.

The channel and riparian area are in excellent condition. There is not even a defined trail in the drainage except for a few game trails. The channel is a B4 type. Flow is ~1 cfs. Bankfull width is ~5 feet. Bankfull depth is ~0.75 feet. The substrate contains very few fines.

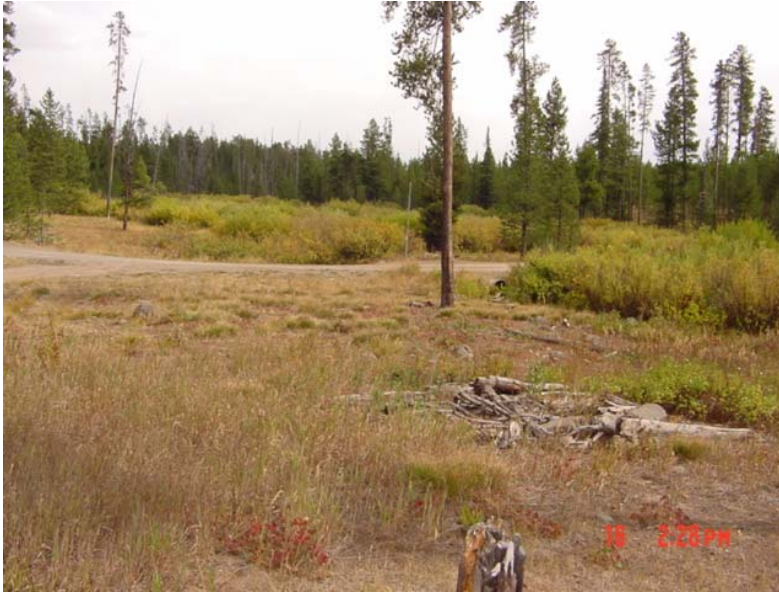
Figure 32 Coffee Pot Creek at FDR 052.

The valley widens and the riparian area is willow dominated. The area in the foreground appears to be an old timber landing and is used by recreationists for dispersed camping. Impacts to the channel are minor at this site.

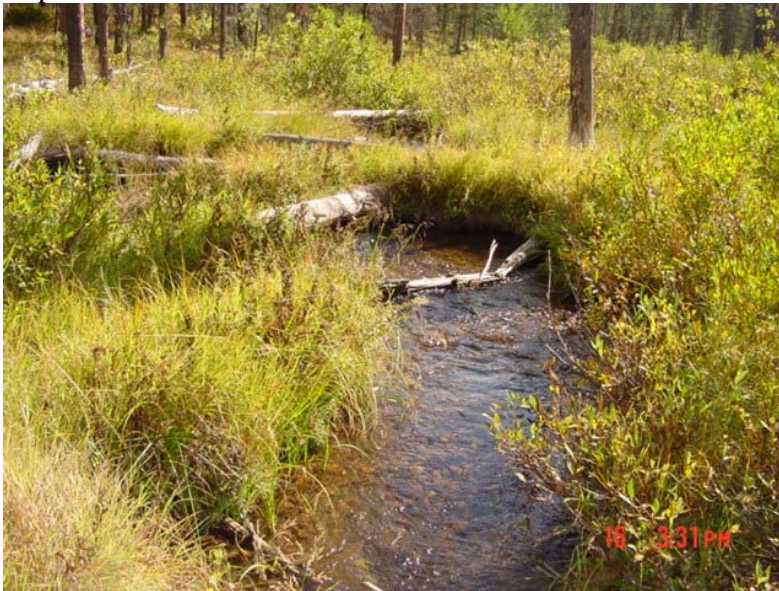
Figure 33 Coffee Pot Creek about ½ mile below FDR 052. Flow is about 2 cfs. Water temperature is about 7 deg. C. The riparian area is willow and sedge dominated and in excellent condition.

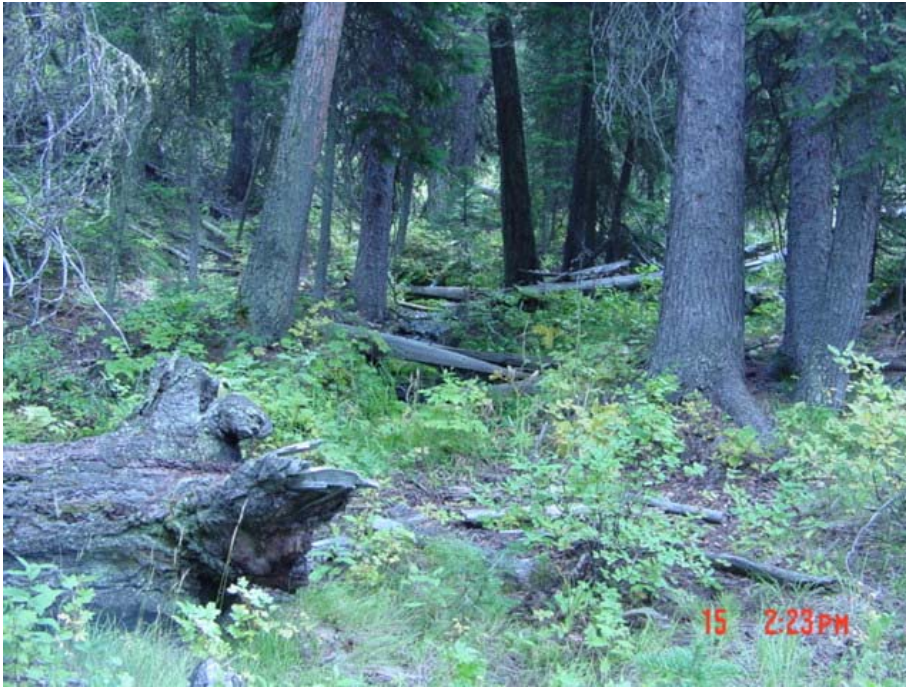
Figure 34 Upper Hope Creek. The channel is barely visible through the vegetation. Flow is about 50 gallons per minute. Temperature is about 6 deg. C. The channel is a B4 type.

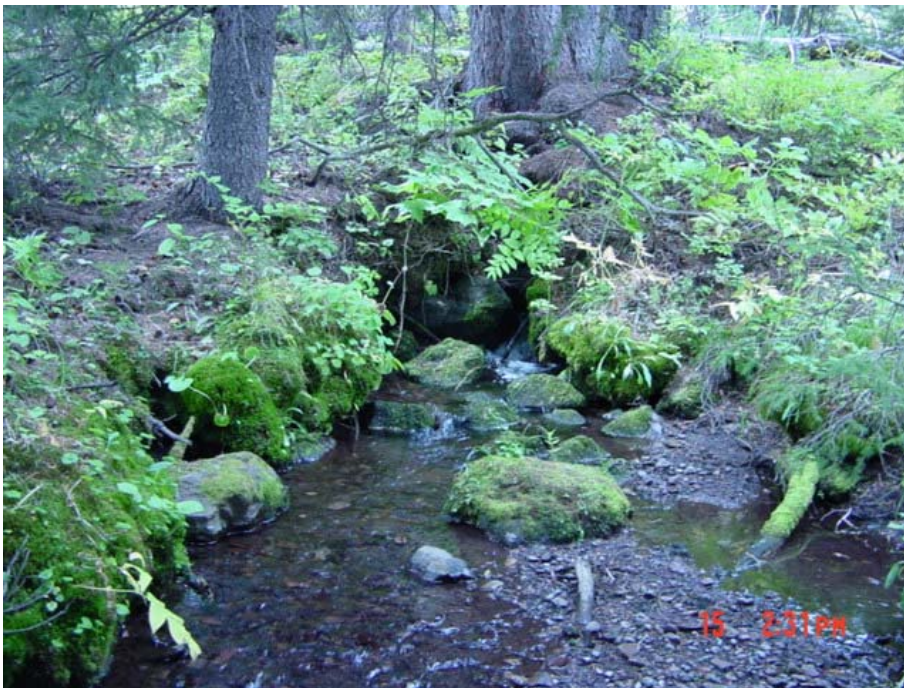
Figure 35 Hope Creek about 1 mile above the Forest boundary. The channel is relatively stable, but gravel and sand is pulsing through the system during higher flows.

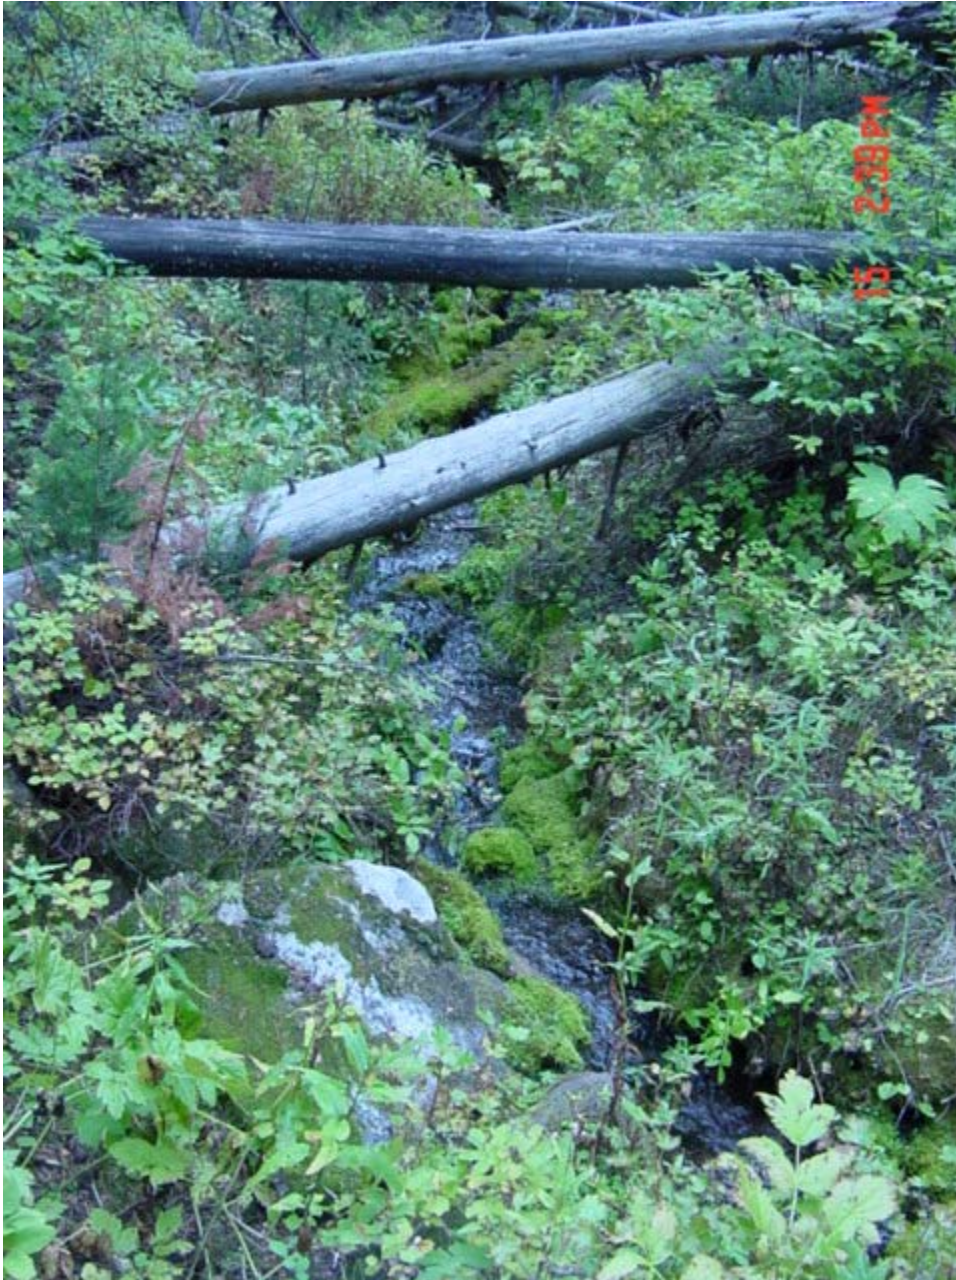
Figure 36 Hope Creek tributary, about 1 mile above the Forest boundary.

The channel is a stable B4 type that is slightly entrenched. Flow is about 50 gallons per minute. The entire drainage above the Forest boundary is relatively pristine. The stream is impacted below the Forest boundary by a ranch.

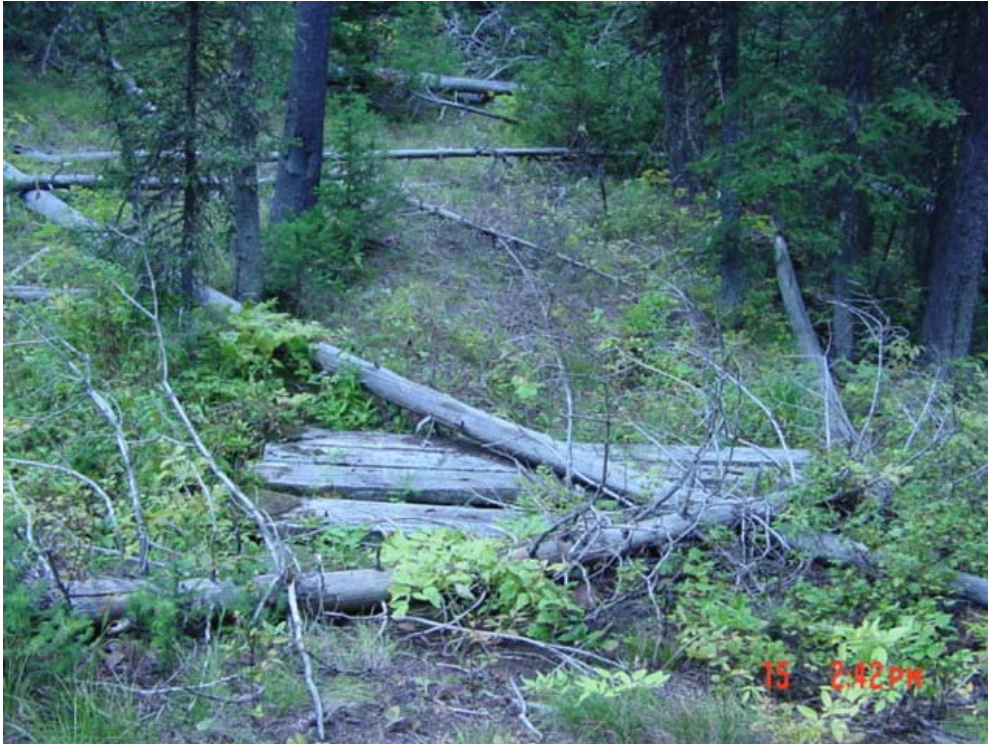
Figure 37 An old bridge crossing Hope Creek about ½ mile above the Forest boundary.

The original purpose for the bridge is unknown, but it is now being used by hikers. An ORV trail is nearby, accessing the drainage from the east. The trail is creating minimal impacts to the drainage and stream channel.

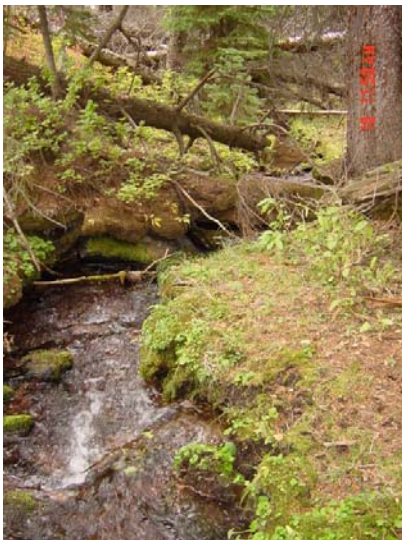
Figure 38 “North” Sawtell Creek about 1.5 miles above FDR 455.

This is a B4 channel type influenced by root wads and large woody debris. Bankfull width is ~ 4 feet. Bankfull depth is ~ 0.5 feet. Flow is about ¼ cfs. The banks have been impacted somewhat by livestock.

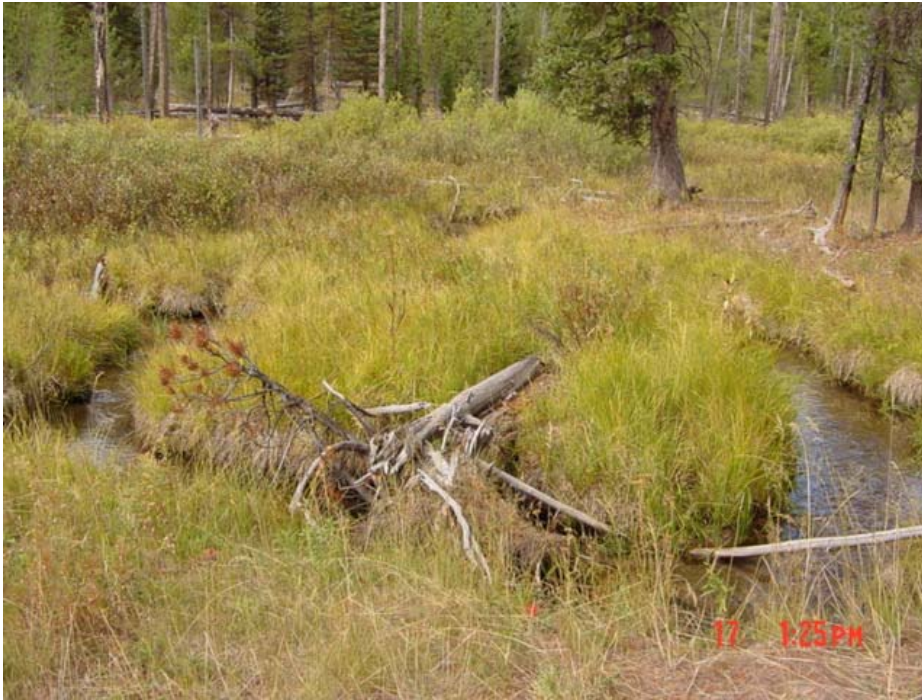
Figure 43 Upper “South” Sawtell Creek is a meandering alternating C and E channel type in very good overall condition.

Though livestock are present, they have had very little impact on the stream and riparian area. Vegetation is dominated by sedges and willows.

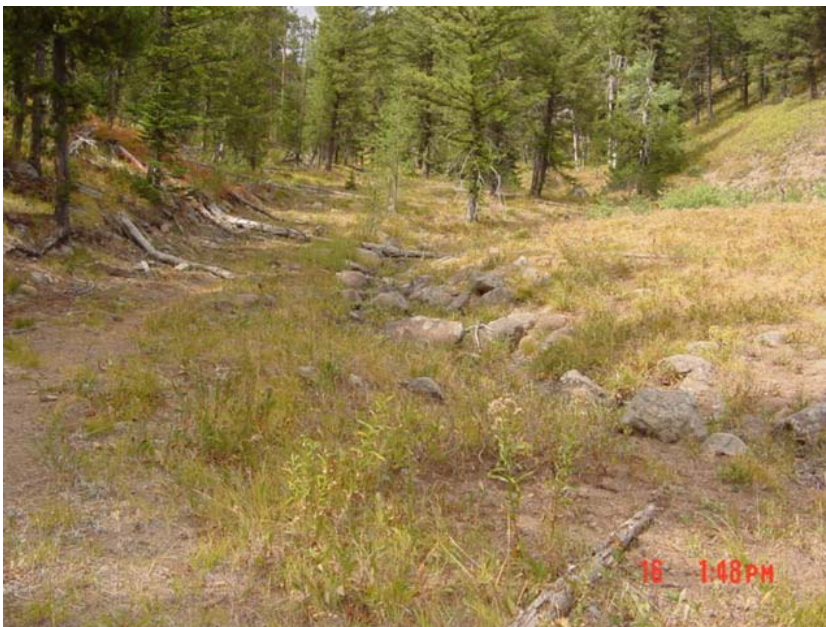
Figure 48 Tyler Creek

Tyler Creek about 1 mile above FDR 052 is a dry channel. An old logging road parallels the channel most of the channel's length. This road has been closed to off-road vehicle travel, but the corridor still exists. Erosion from the road is currently minimal.

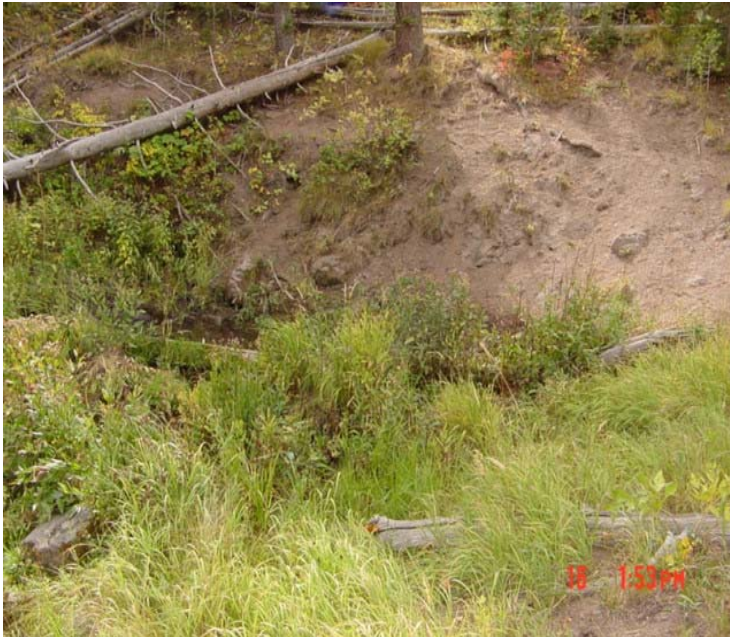
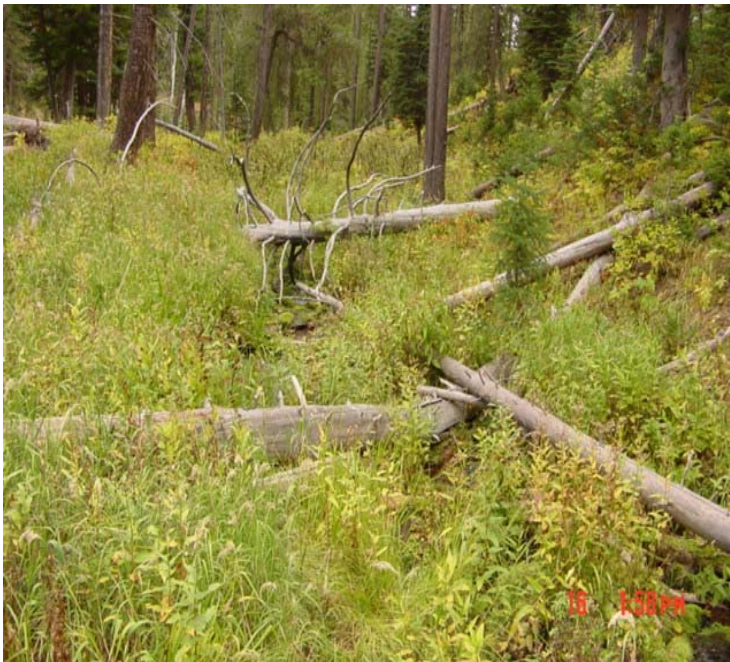
Tyler spring marks the headwaters of the perennial flows. Water temperature is 5 deg. C. At Coffee Pot spring, the site has been impacted by elk.

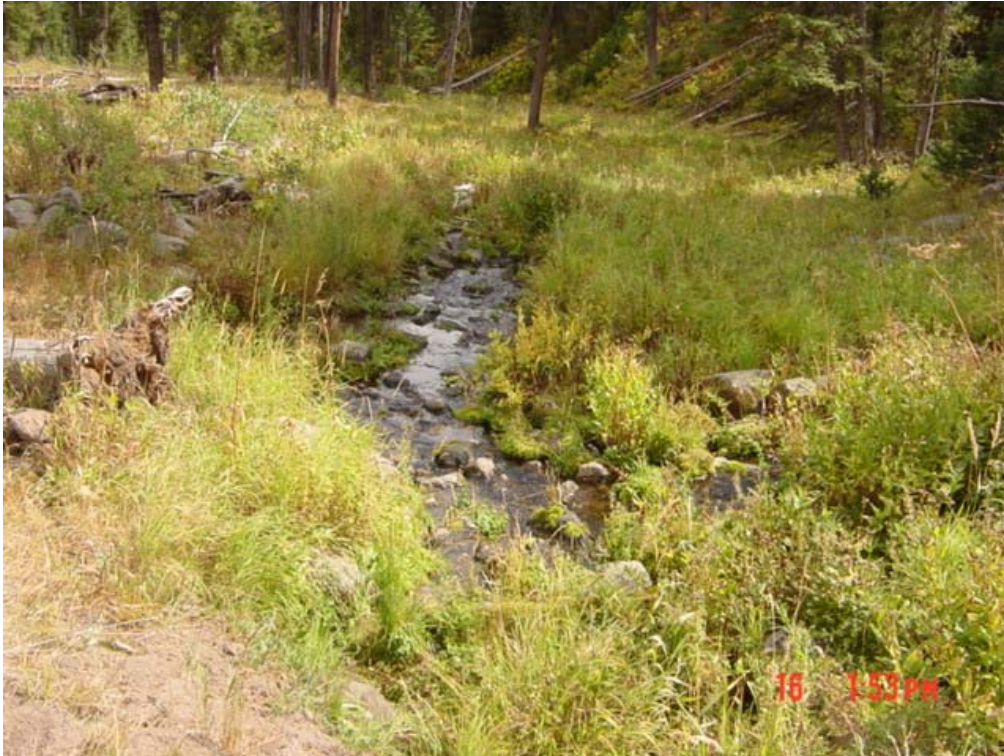
Figure 51 Tyler Creek just below the springs. Flow is about 50 gallons per minute. Elk signs are prevalent.

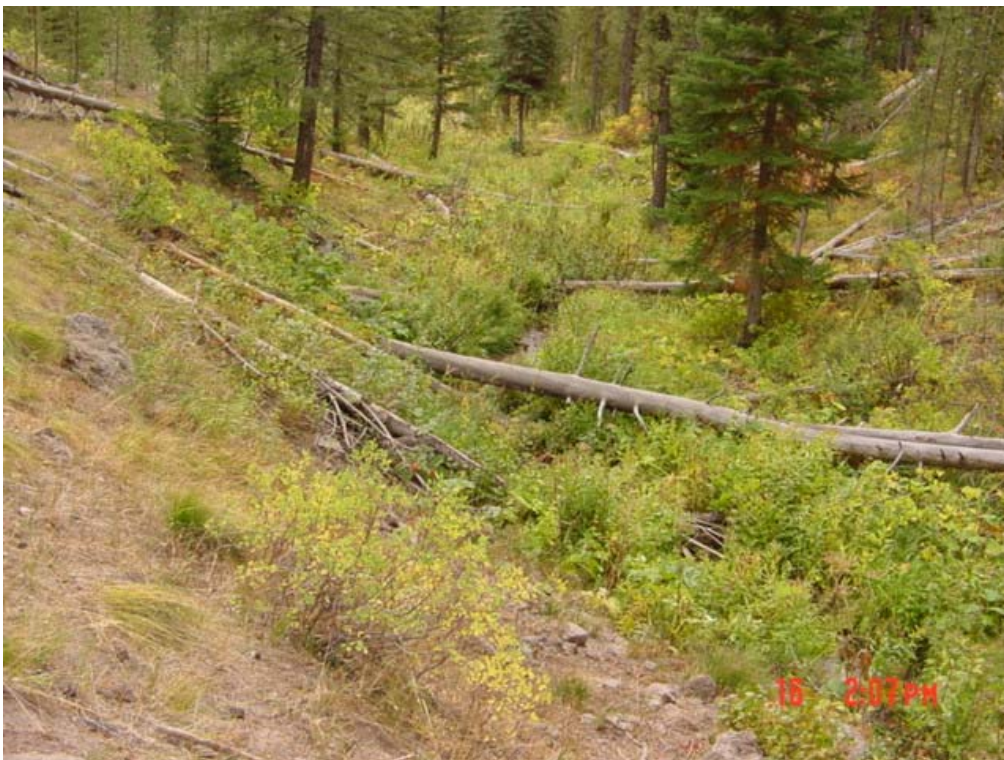
Figure 52 Tyler Creek just below the springs

Below the spring Tyler Creek becomes a B3 channel type. Bankfull width is ~ 5 feet. Bankfull depth is ~ 0.6 feet. Flow is less than ¼ cfs. Riparian vegetation is very good, consisting of assorted willows and other shrubs, sedges, forbs and conifers.

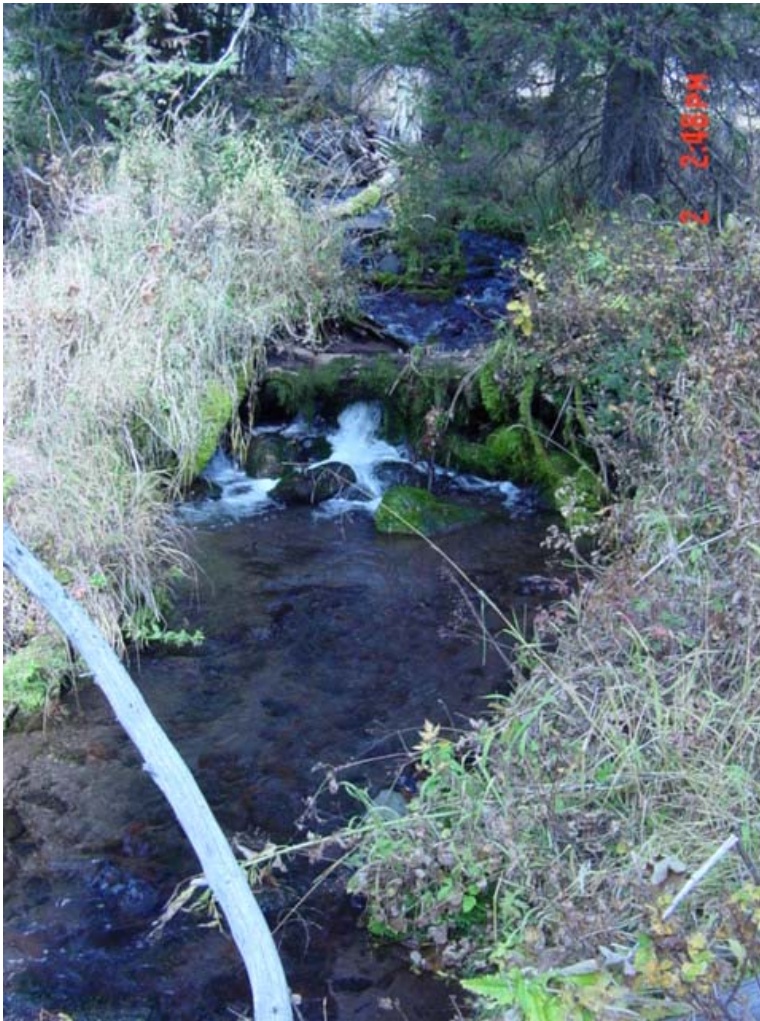
Figure 53 Arange Creek

Typical reach above West Fork Hotel Creek confluence. Bankfull width is ~ 6 feet. Bankfull depth is ~ 1 foot. Boulder/cobble substrate in riffles with ~ 25% - 50% sand embeddedness. Pools are 50%+ embedded with sand. Flow is ~ 3 cfs. Water temperature is 7 deg. C.

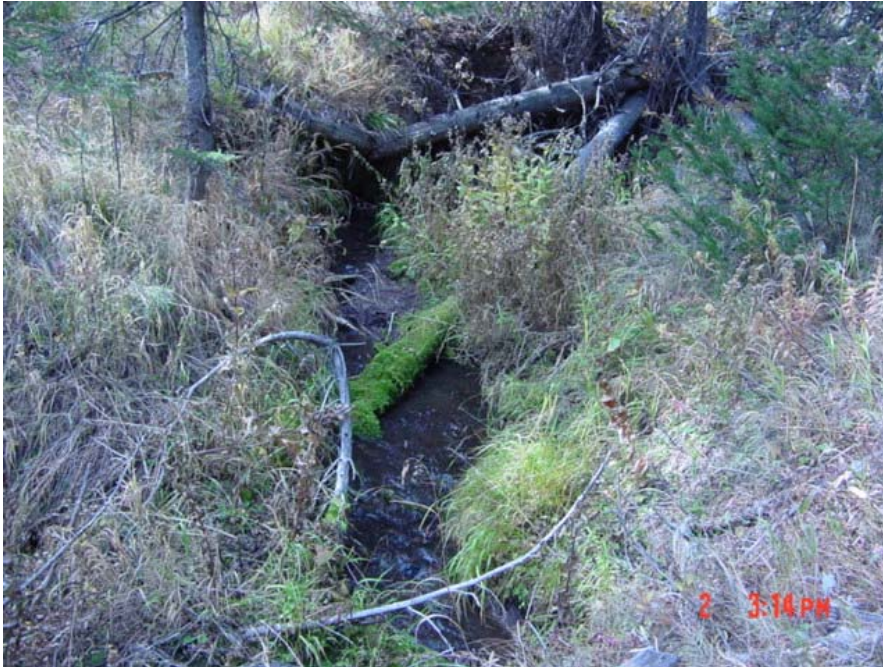
Figure 54 “West” Fork Arange Creek.

Figure 54 Flow is $\sim 1/4$ cfs. Bankfull width is ~ 3 feet. Bankfull depth is ~ 0.5 feet. Temperature is 8 deg. C. B4 channel type with gravel bed.

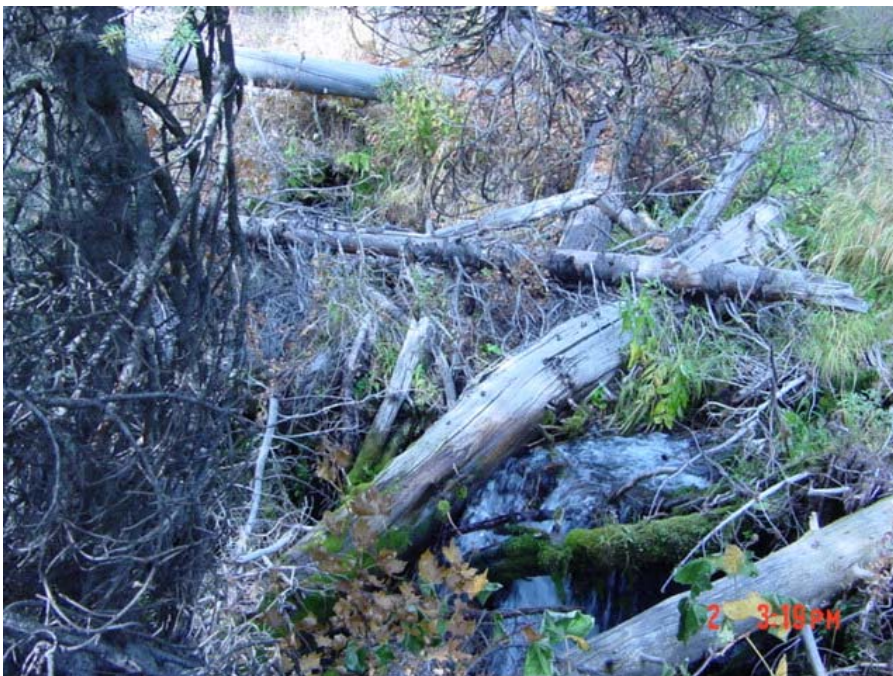
Figure 55 Confluence of mainstem/”west” Fork Arange Creek.

Figure 55 “West” fork is visible in the upper center of the photo. The main stem enters from the right of the photo.

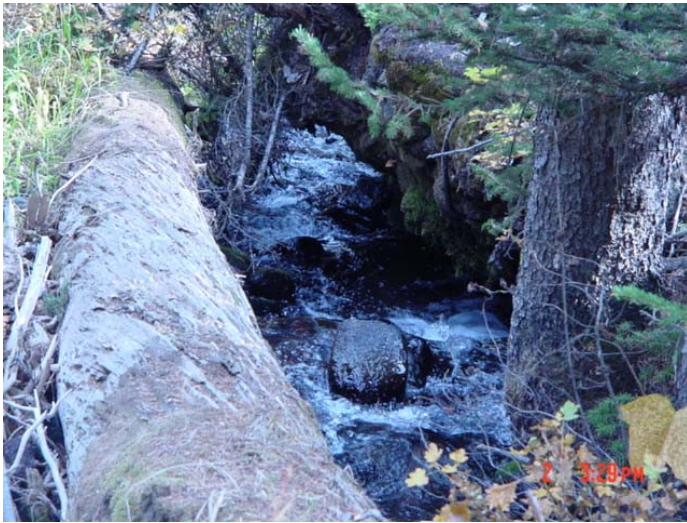
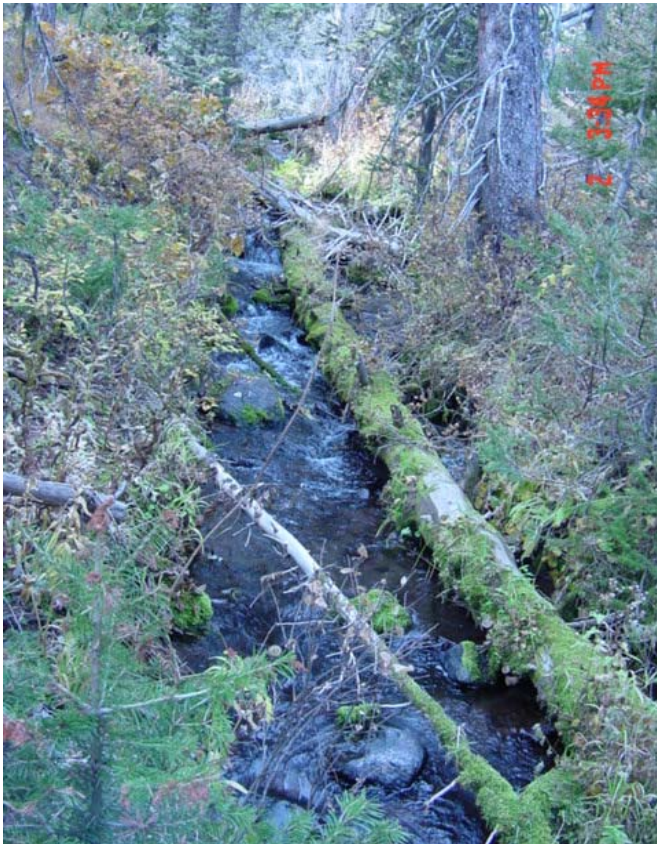
Figure 56 Typical reaches of Arange Creek below main stem/West Fork confluence.

Figure 57 Typical reaches of Arange Creek below mainstem/West Fork confluence.

Typical reaches of Arange Creek below mainstem/West Fork confluence. $Q = 3-4$ cfs. Bankfull width ~ 7 feet. Bankfull depth ~ 1 foot. Stream channel and riparian area are in excellent overall condition. (Figure 56, Figure 57)

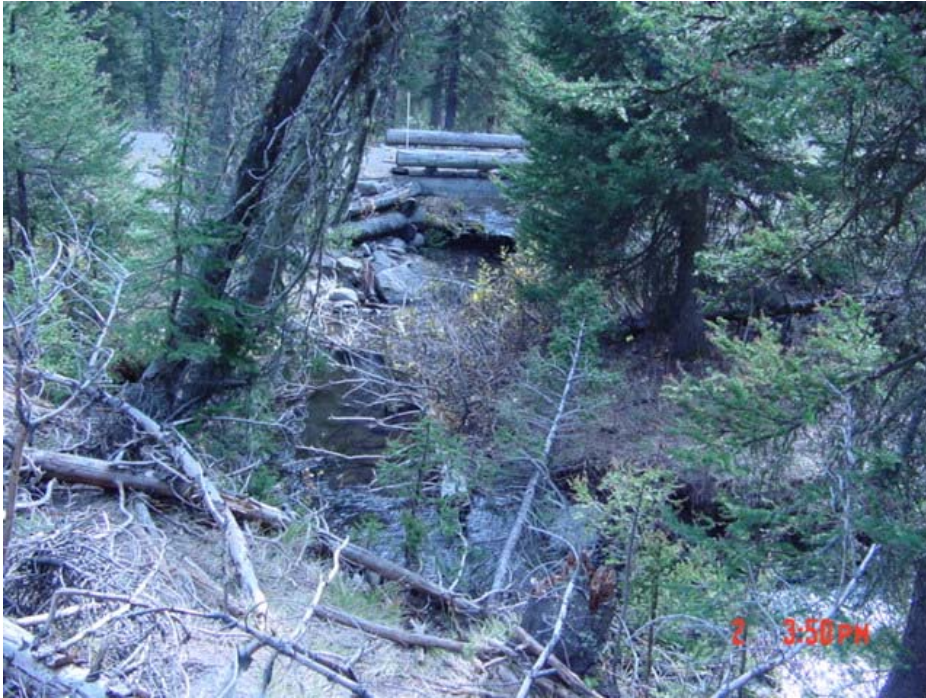
Figure 60 An old bridge on FDR 048.

Figure 60 shows an old bridge on FDR 048. This section of the road has been closed, but the bridge remains. It is not influencing the stream and there is no immediate need to remove it.

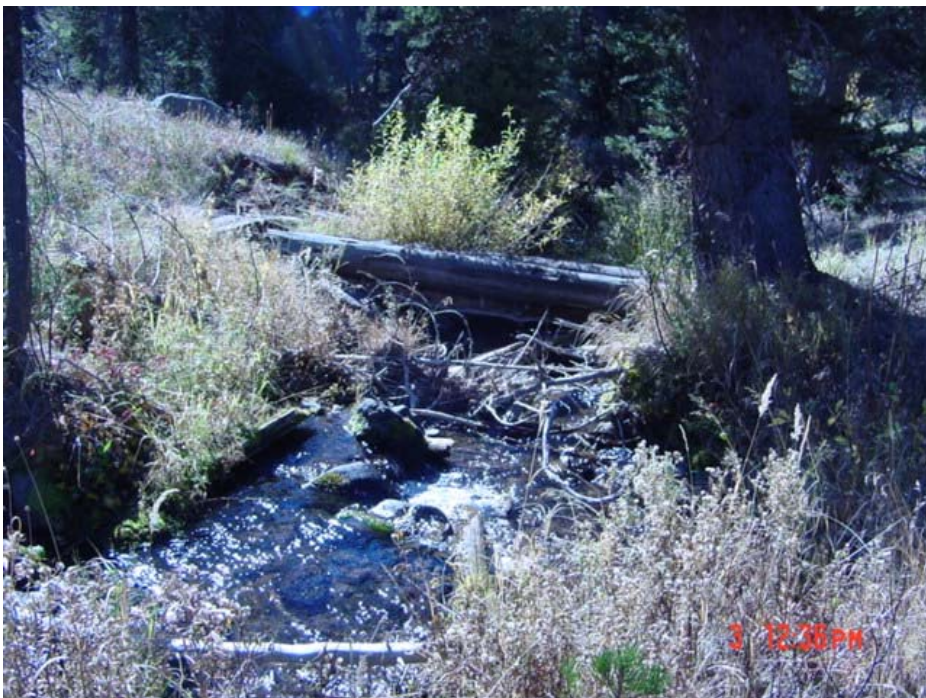
Figure 61 Another old bridge, possibly part of an old livestock driveway. The willow growing through it indicates it hasn't been used for many years. There is no impact to the stream.

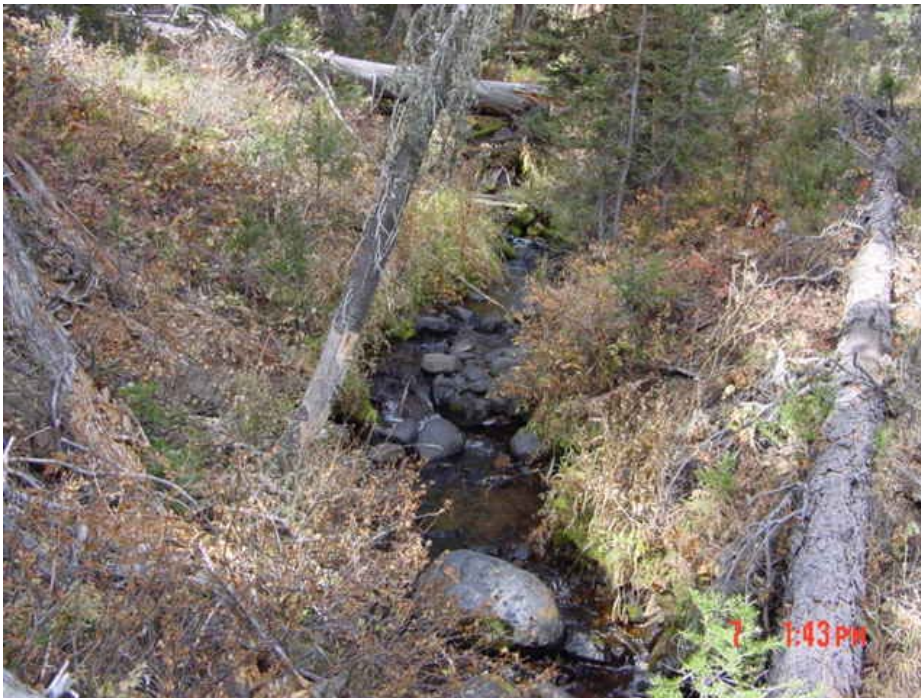
Figure 64 West Fork about $\frac{3}{4}$ mile above the FDR 048 crossing. The channel is relatively unobstructed by debris and fine materials have been transported through this section.
